2013 Cotile Lake Aquatic Vegetation Control Plan

Waterbody type – Wooded impoundment

Appendix II – Photographs of control structure.

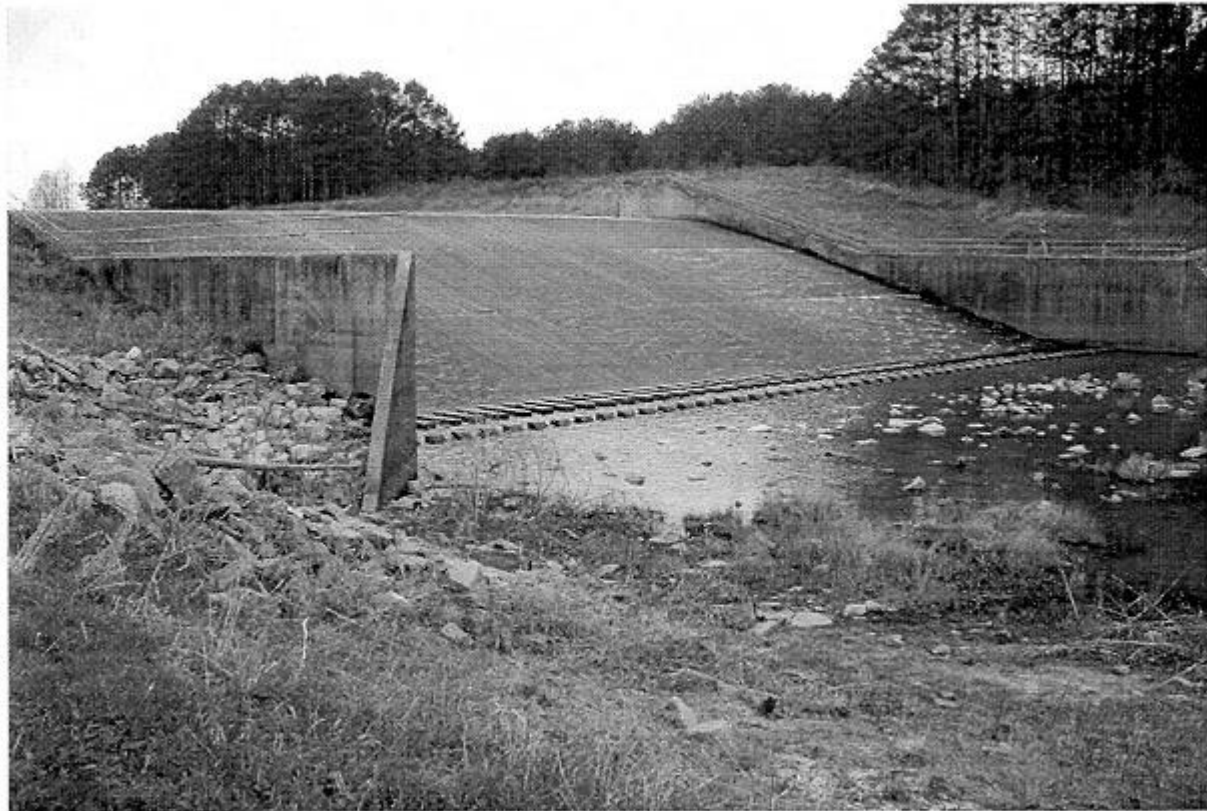
Photo No. 1: View of the principal spillway

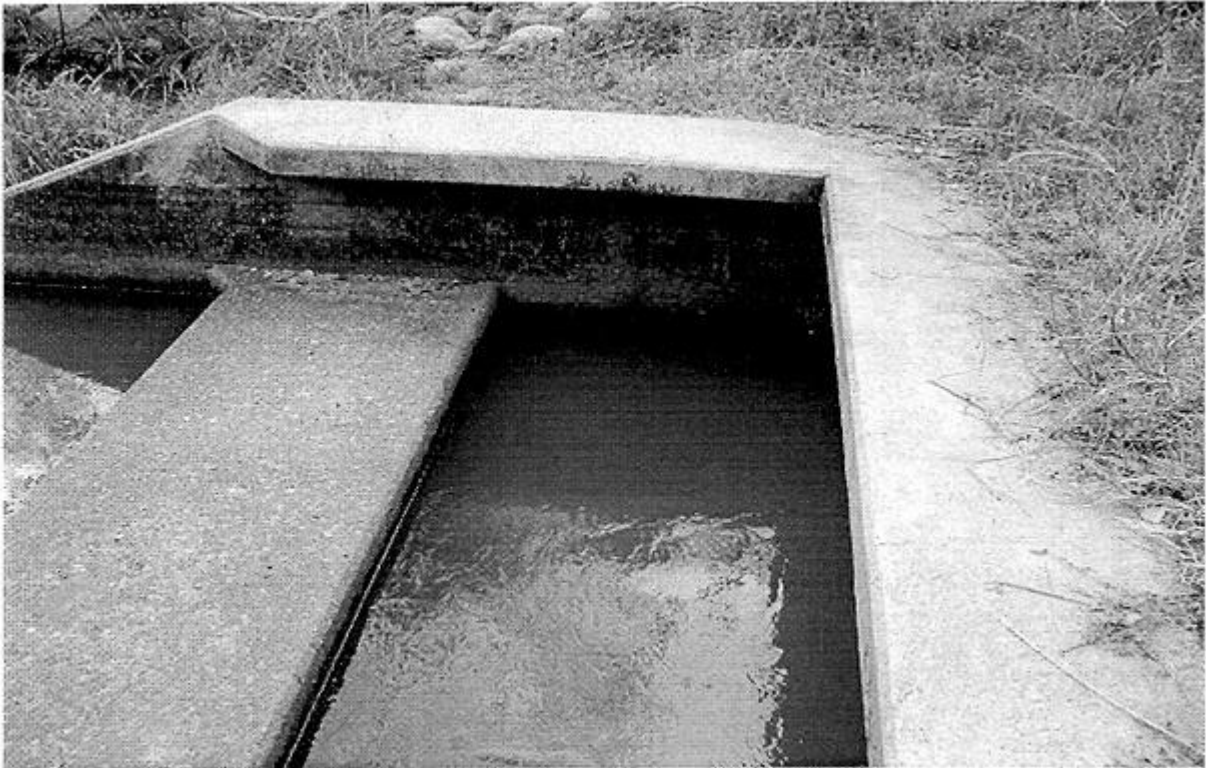
Photo No. 10: View of the discharge structure.

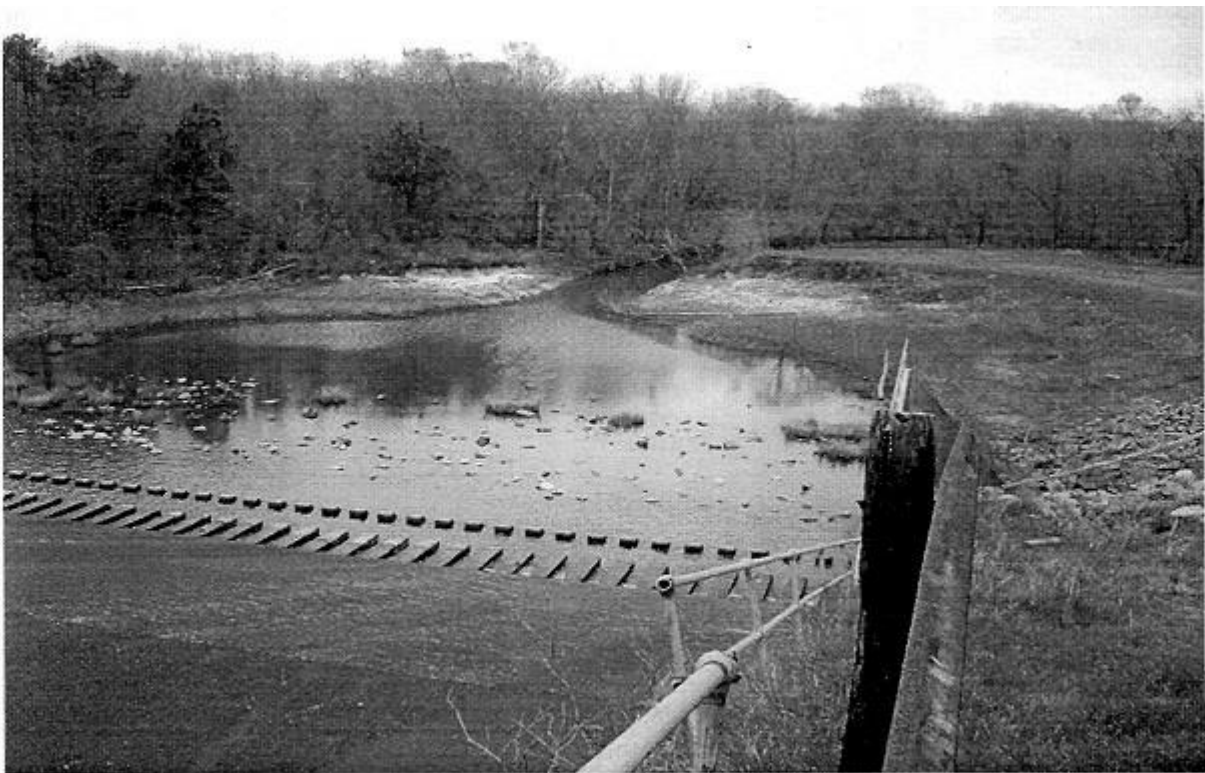
Photo No. 2: View of the principal spillway

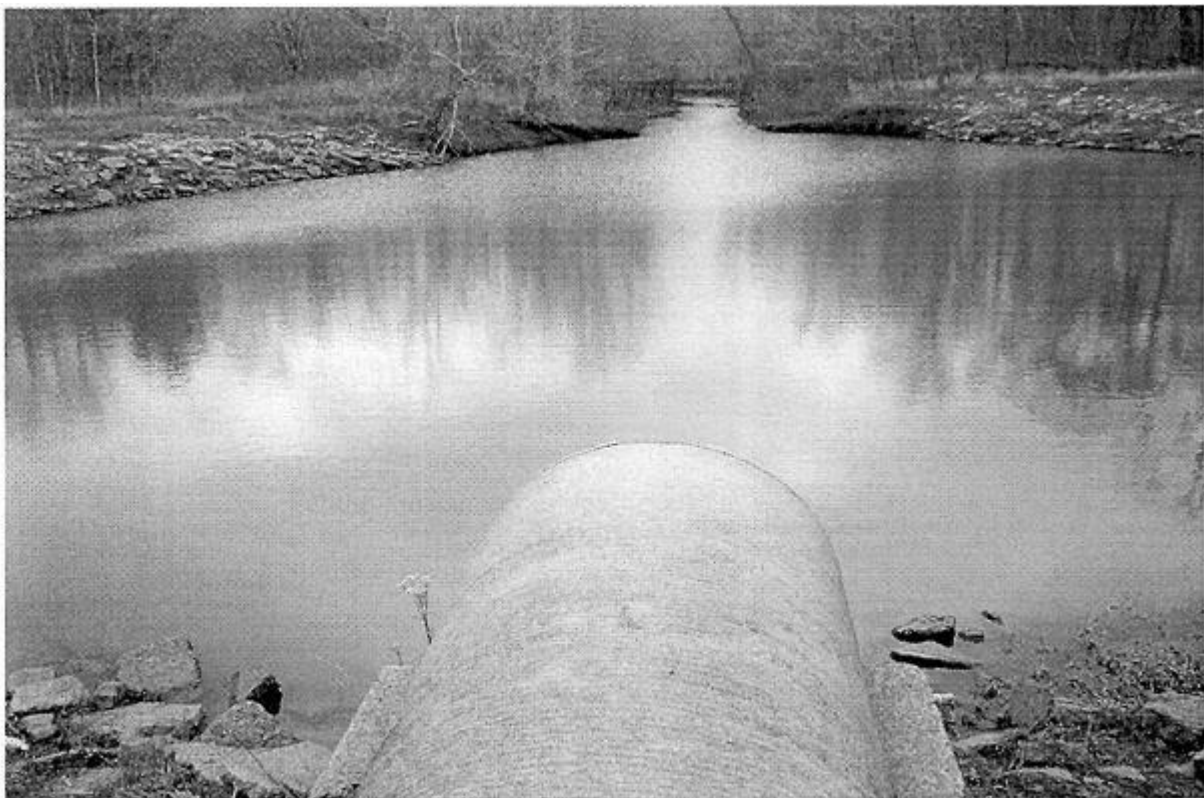
Photo No. 3: View of the 60 inches diameter (inside diameter) 320 foot long discharge reinforced concrete pipe culvert.
